Trent Park North Lake Restoration Proposals

A guide to how Enfield Council will help restore and manage the landscape of the north lake

Restoration of the Historic Landscape at Trent Park Mansion and Lake

Trent Park, Enfield
Document Reference: 1441/023 Rev C
May 2024

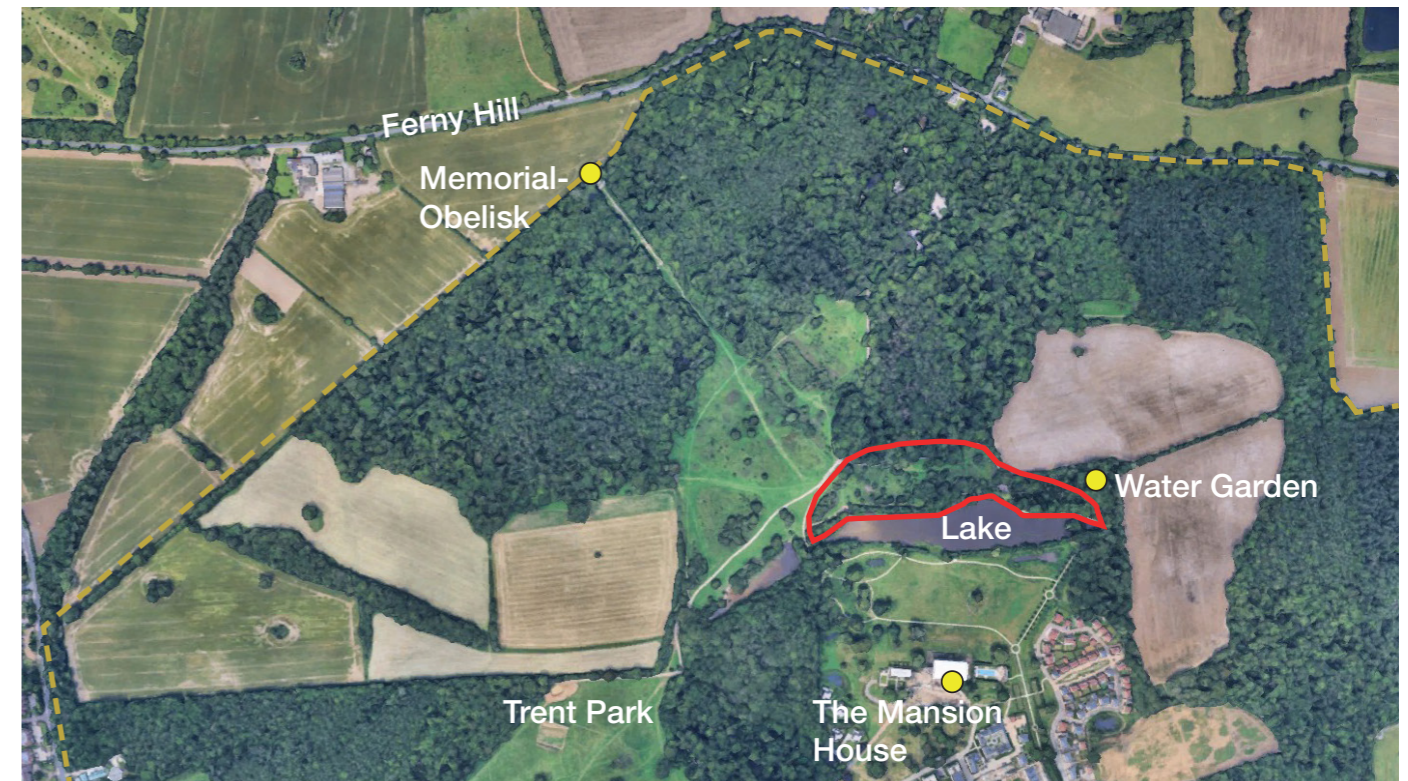
Aerial view of Trent Park showing the north lake area

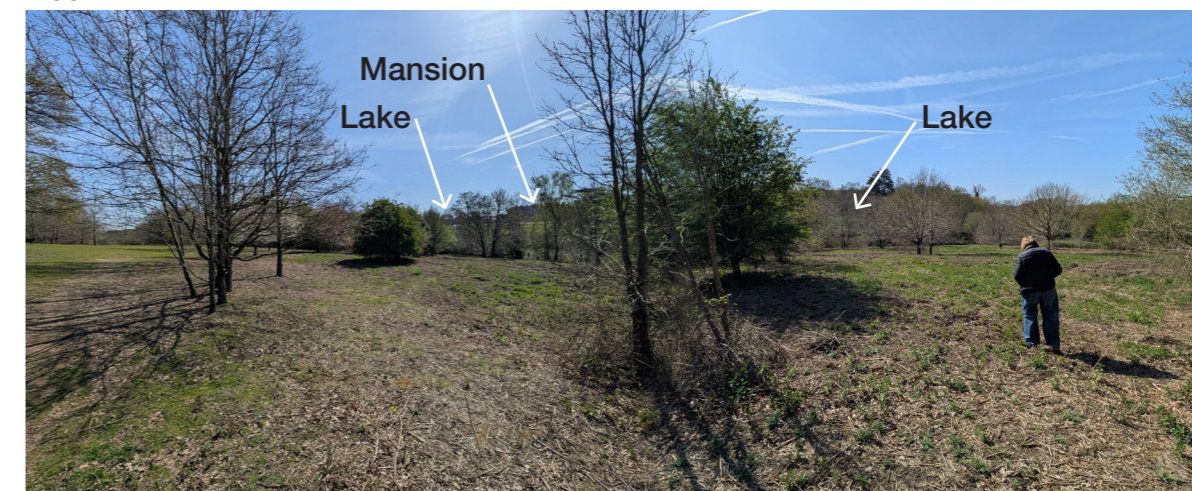
View of the north lake site taken in February 2026 after bramble and low scrub cutting

In February 2026 we cleared the site of all the areas of thick bramble and small saplings to help open up and better assess the site. A qualified arboriculturist has surveyed and assessed the best tree specimens for retaining. These present a good range of species and age to ensure the greatest benefit to biodiversity. We also consulted an ecologist to ensure we are compliant with environmental regulations and our plans enhance biodiversity.

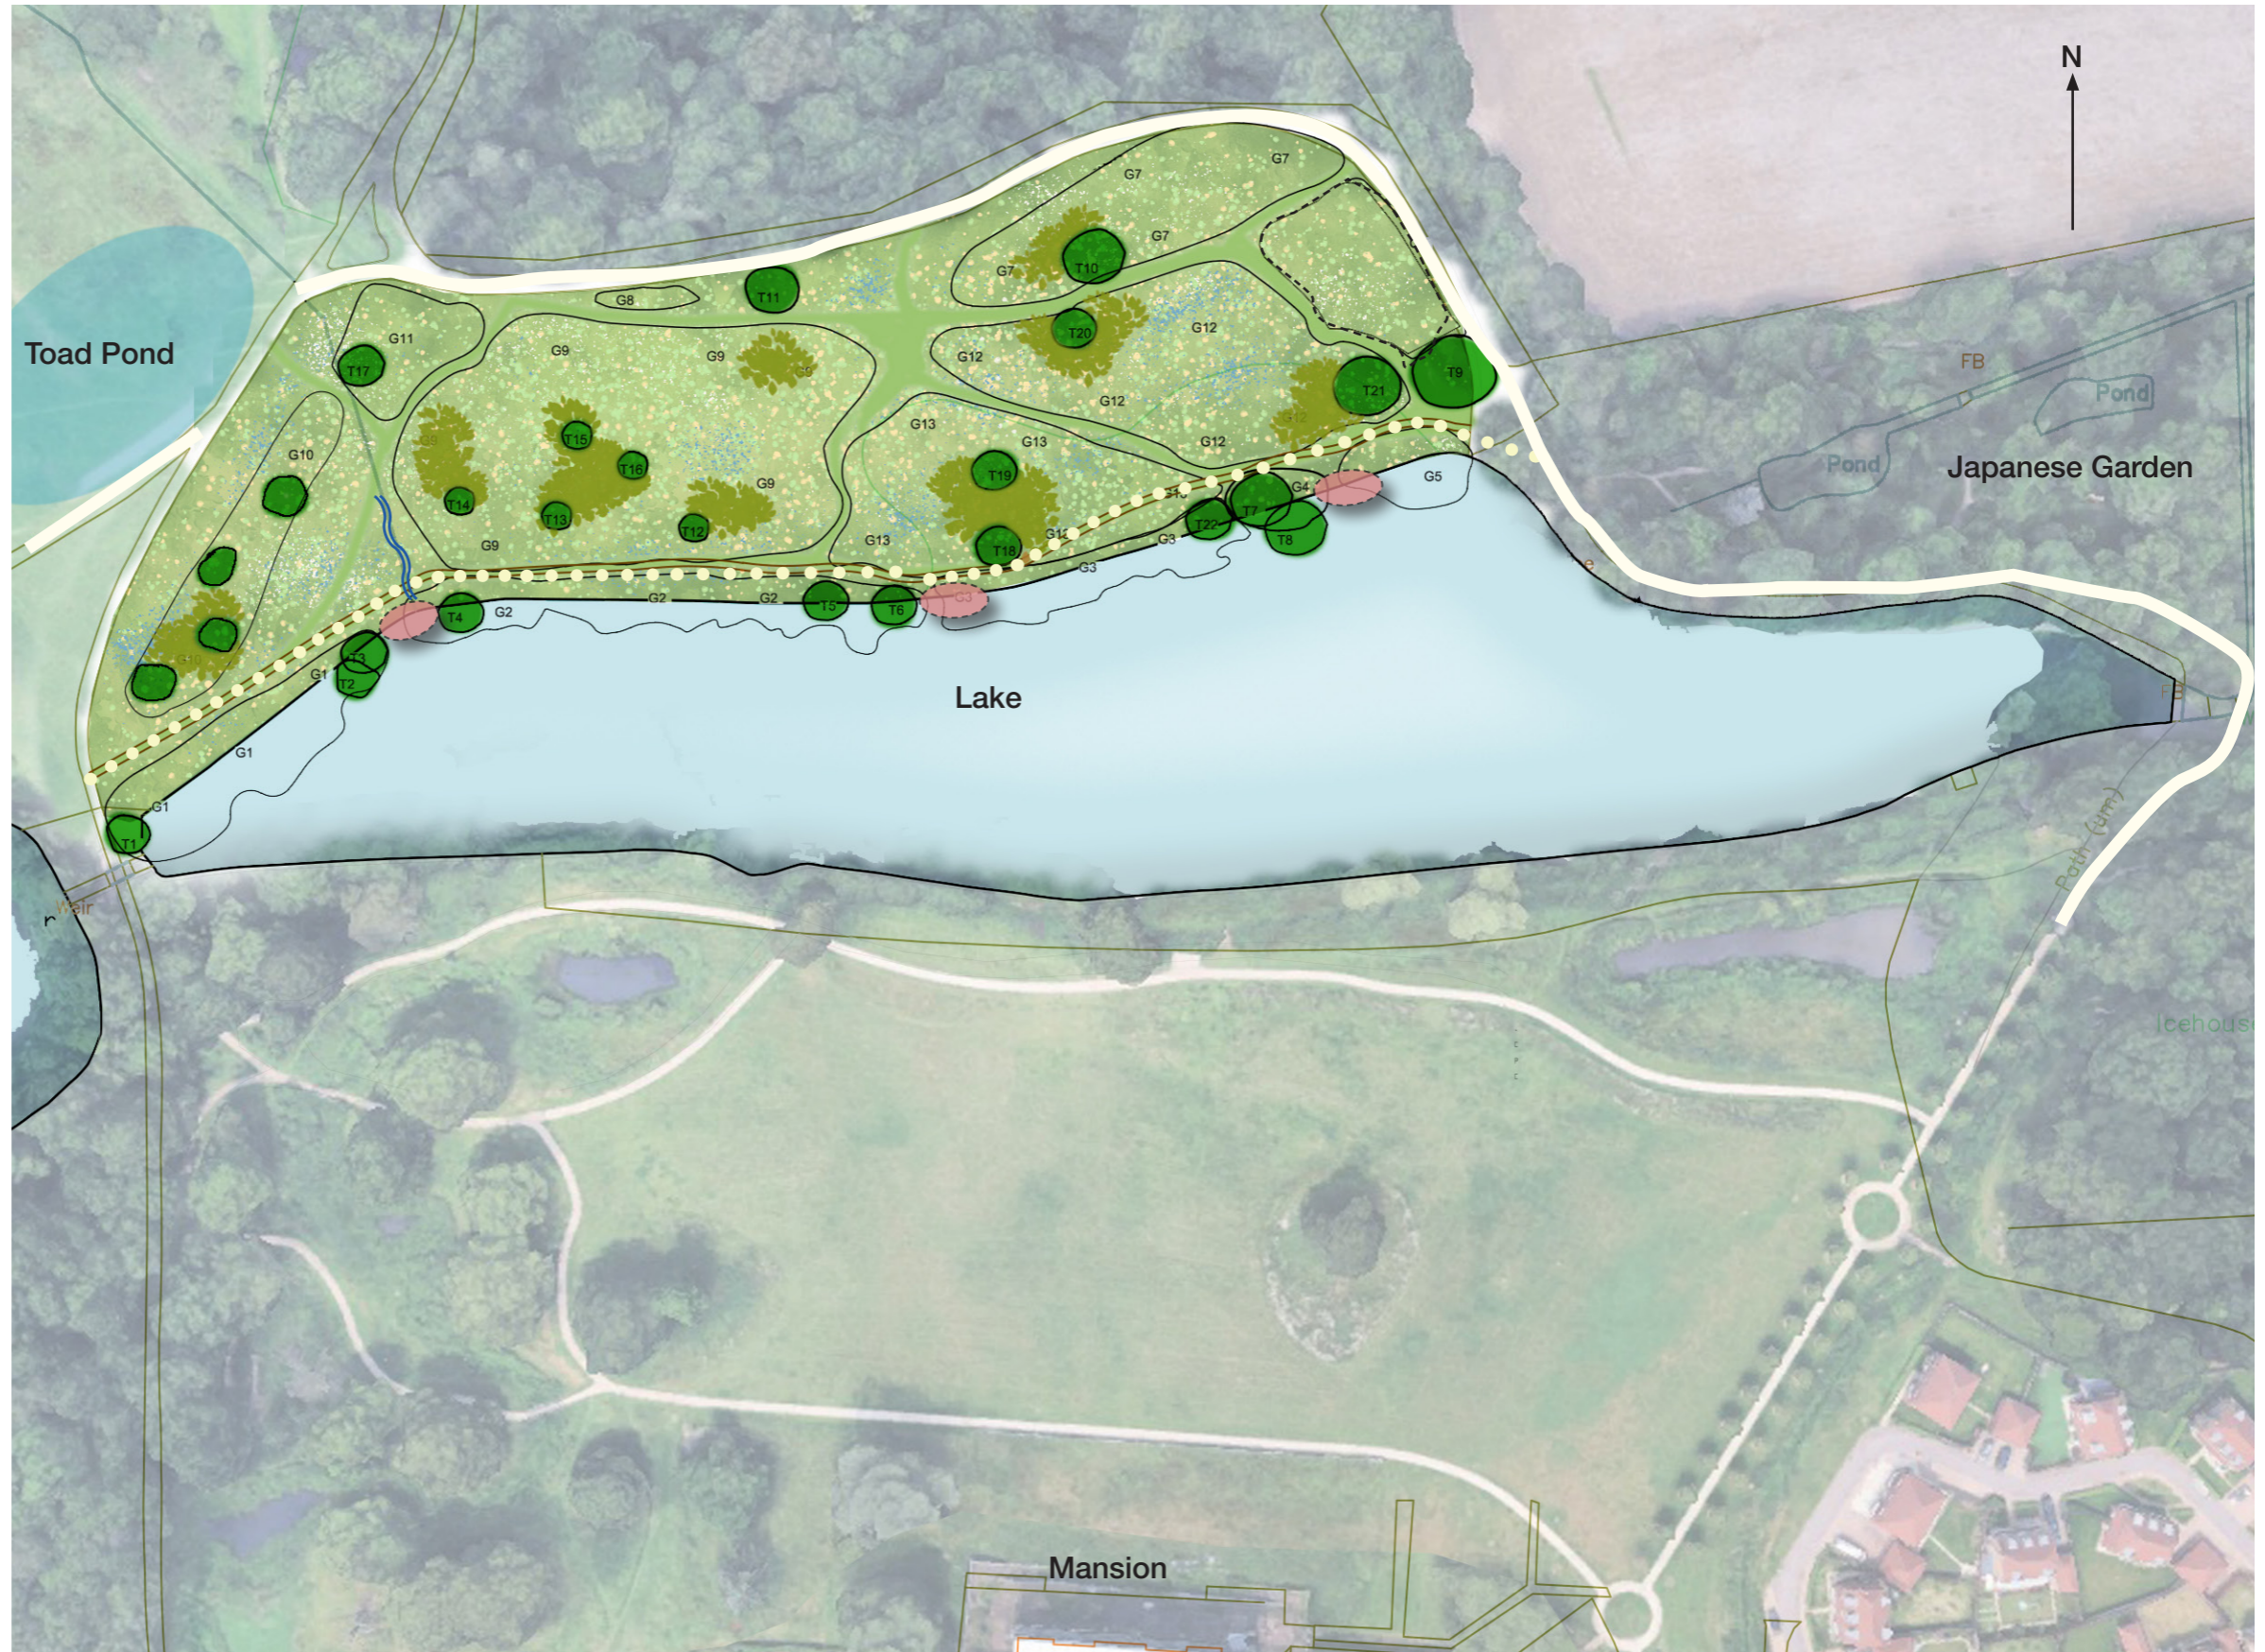
Plan showing landscape restoration proposals for the north side of the lake

Our plan (on the following page) shows indicative areas of retained pockets of scrub (selecting the best most diverse areas) to be managed on a 2-4 year cutting cycle. We believe this will offer the greatest benefit to local wildlife whilst also achieving the objective of improving the historic views. The council is now in a strong position to coordinate this management. Trent Park falls within the heart of our Landscape recovery scheme which will bring a greater focus and monitoring ability to the landscape management. In addition a woodland management plan is being produced by our in-house woodland officer which focuses on woodland regeneration, but also recognises the value of thinning and opening up areas and is therefore aligned with this area. Our Parks team are fully onboard with this management approach and are investing in machinery to help accomplish the scrub cutting cycles more effectively, (e.g.. investing in a Robomulcher to easily remove bramble and saplings) using a dedicated maintenance budget secured through this project.

Retained tree
-

Retain some scrub area with a 2-4 year cutting cycle
-

Removal of majority of tree and shrub vegetation, scrape out bramble and sow a meadow
-

Proposed route of new lakeside footpath (self bound gravel)
-

Lake edge improvements - various locations requiring bank support/erosion protection
-

Potential to replace existing pipe with a swale and mini wetland feature

Between the pockets of scrub and the retained trees we propose to create a grassland meadow habitat. We propose to scrape off the top layer of soil and remove the worst of the bramble roots (off-site). We have an on-site location to deposit the soil arisings and gently blend into a naturally undulating landscape. This then allows us to sow native wildflower meadow seed into an ideal substrate. Our Parks team are now set up for future seasonal cut and collect management.

Along the lake edge we are proposing to remove the majority of alder and willow trees whilst retaining a few of the best specimens. In addition we will carry out improvements to protect the lake edge from erosion using natural materials and techniques such as piling in timber and forming retaining edges of branch/brush bundles and backfilling with soil, then planting marginal vegetation. We also propose to address the erosion issues around the western edge where a drainage pipe outfalls and is the most frequent area for dogs to enter the lake. Here we propose to formalise a dog entry area to help manage this activity and make a more vegetated and natural setting around the pipe.

If the budget allows we would also like to install a new footpath around the north lake to connect to the path around the south side. We propose a self bound gravel material, the path would follow the existing desire line and provide an improvement to the existing situation which becomes very muddy. We hope to include some wayfinding and interpretation features and seating opportunities to complement the lakeside environment.

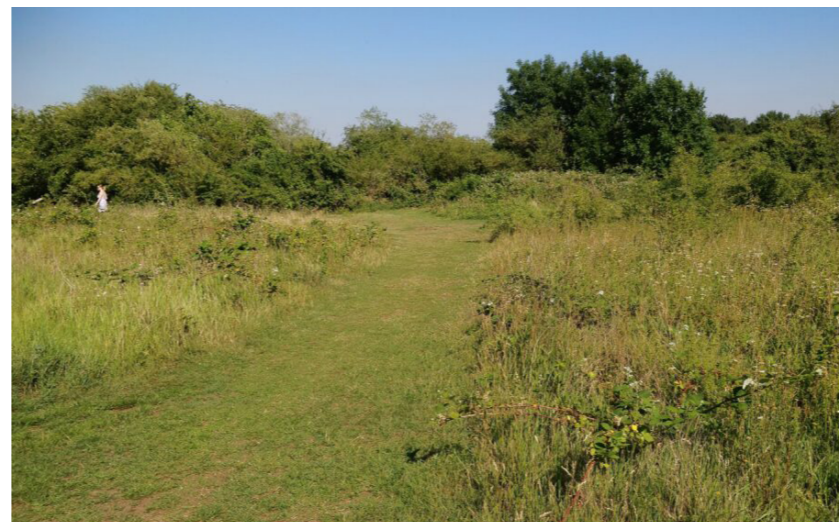
Example of grassland meadow and scrub areas with mown path

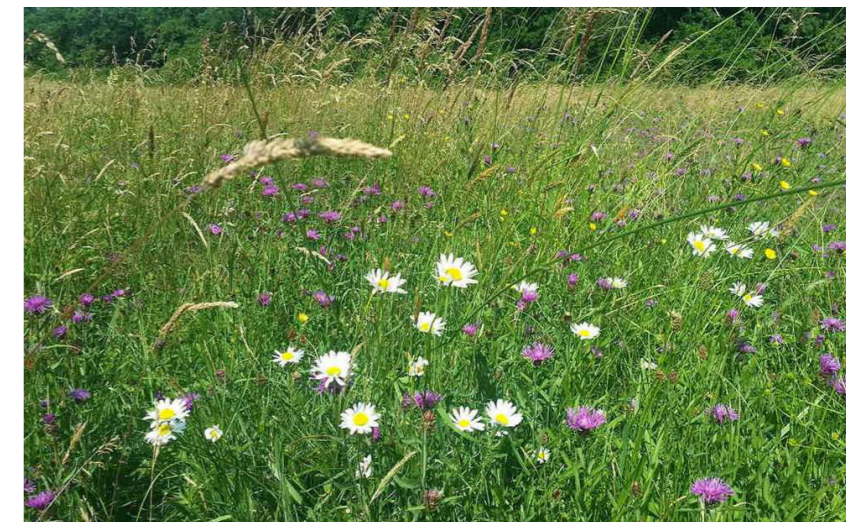
Example of grassland meadow typical species

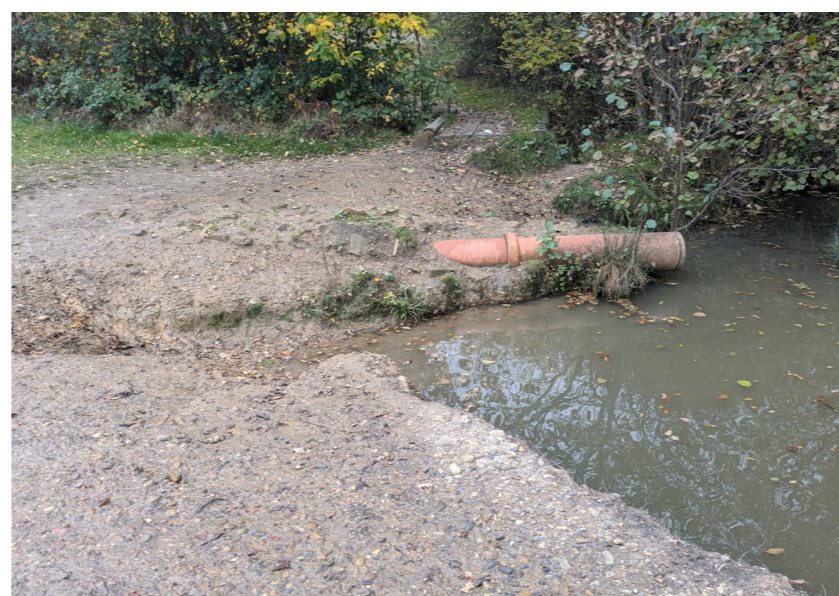
Example of erosion at Trent Park Lake, potential to remove the pipe and create a swale and mini wetland area along with a formalised dog entry area with erosion protection.

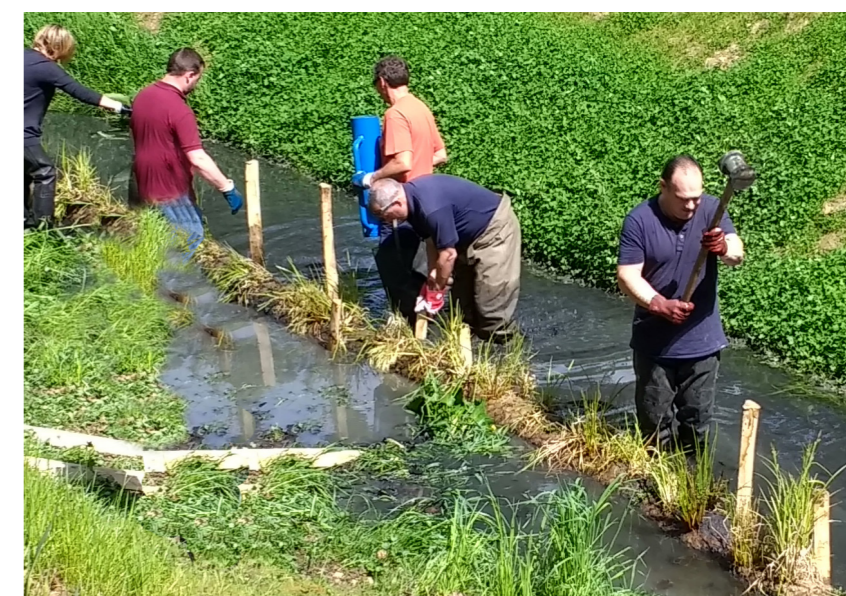
Community event at Firs Farm creating a vegetated river bank support using natural materials.

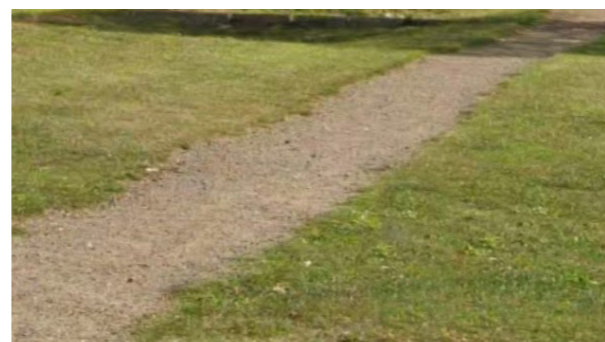
If budget allows the project offers an opportunity for a footpath made from self bound material similar to the path on the south side of the lake to form a circuit around the whole lake. Current proposal is to follow the main informal existing 'desire line' route (shown on proposal plan)

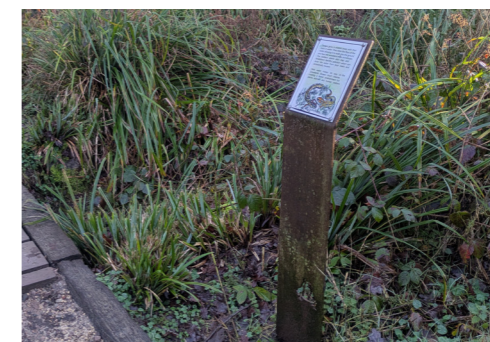
The project offers an opportunity for some interpretation signage to inform visitors of the historic landscape and management objectives. This could form a nature trail around the lake

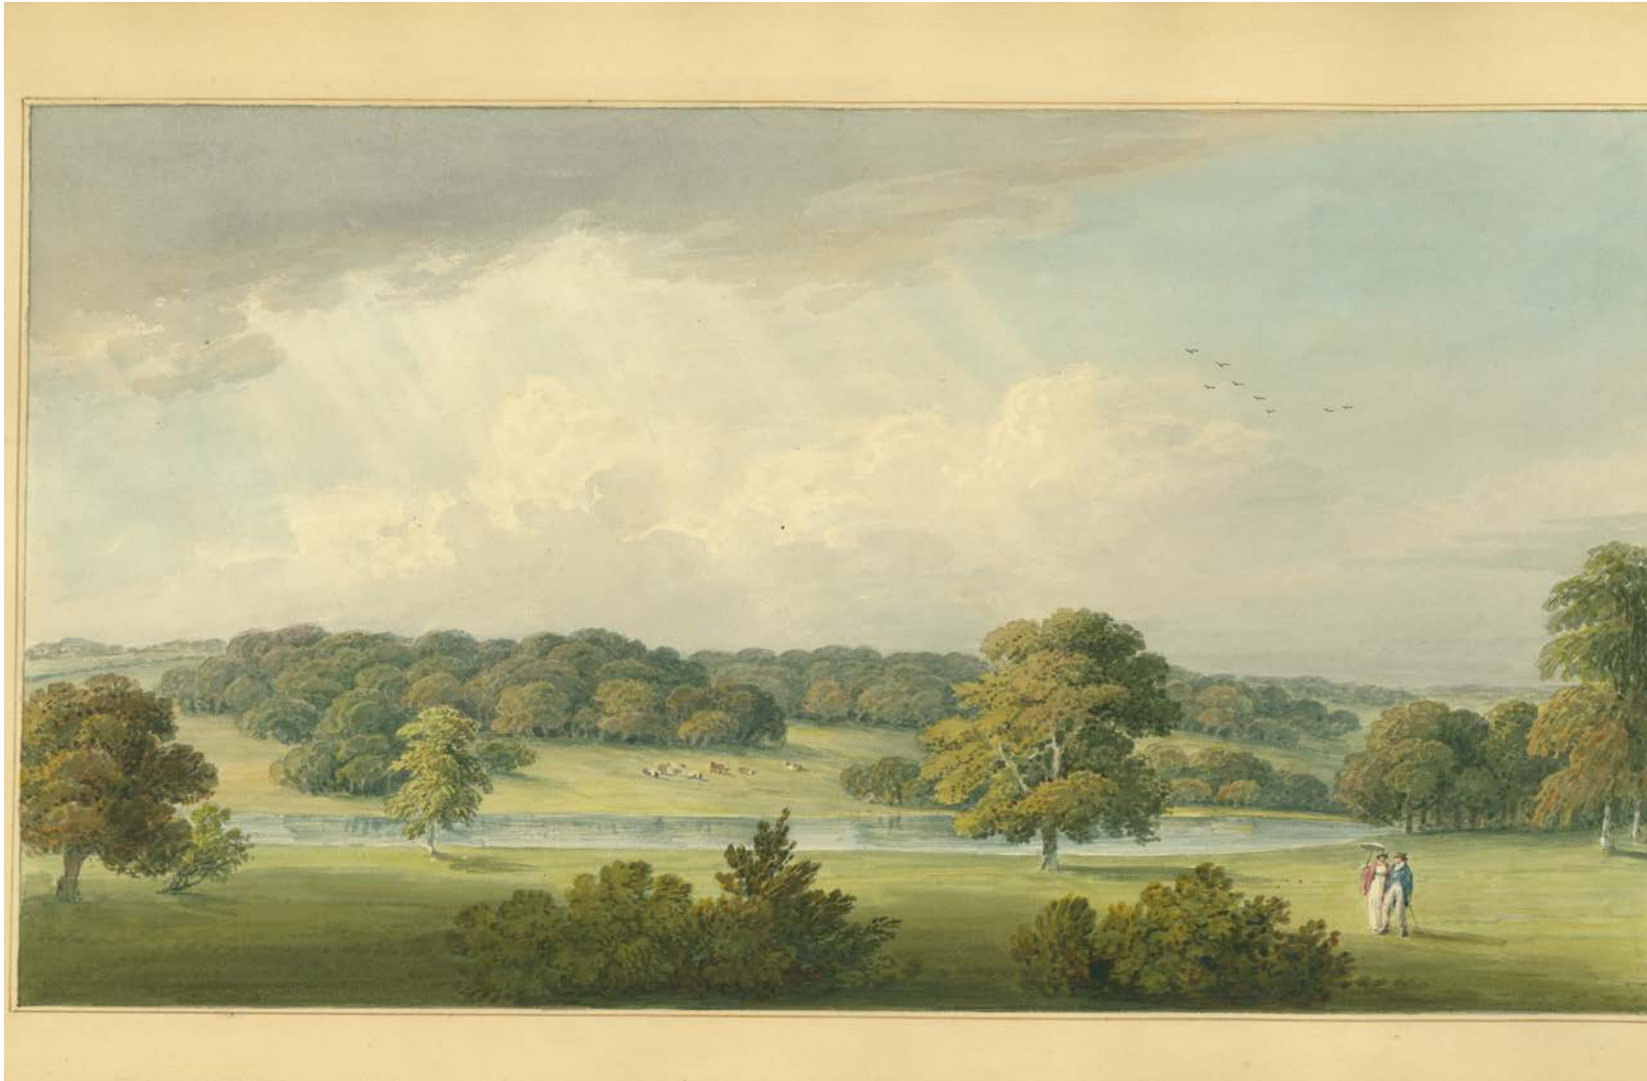
Figure 2 - Lewis Kennedy's watercolour, 1815.

A villa was built on the site of the present Trent Park mansion shortly after 1787. Lakes were present soon after this. The first evidence of a lower lake and the woodland above it in their present form is Kennedy's watercolour of 1815 (figure 2). This shows the lawn extending down to the water's edge from the mansion and grassland on the other side.

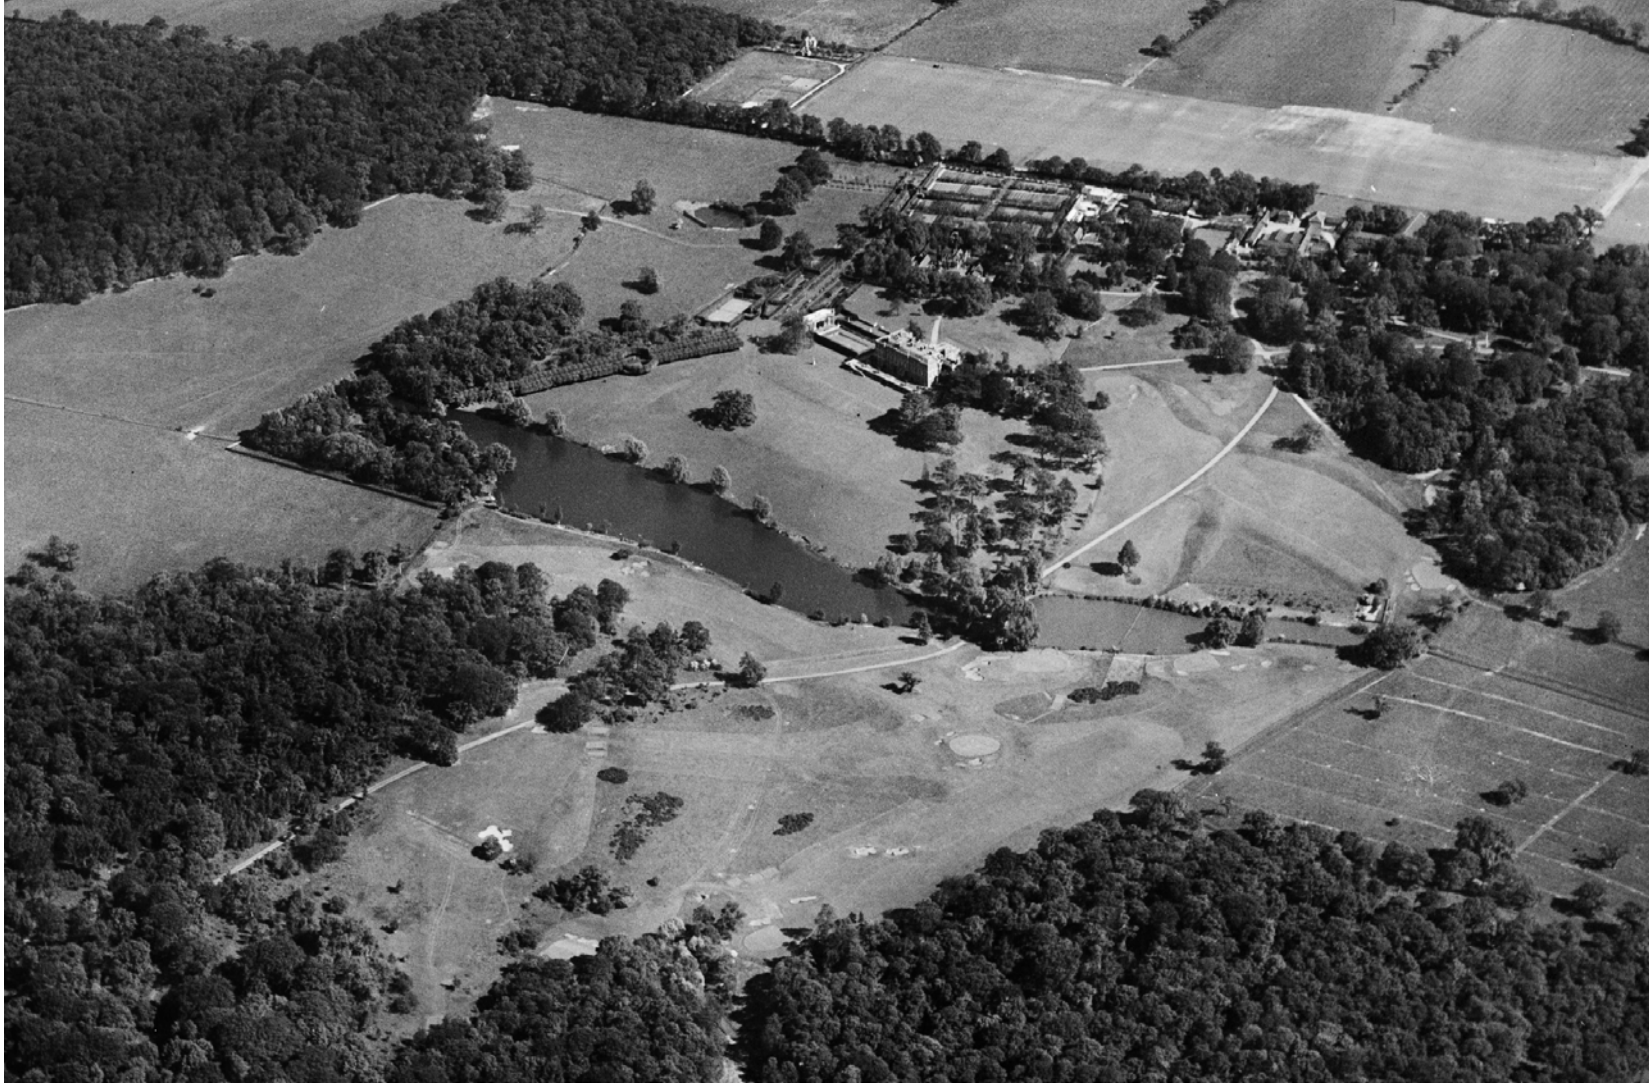
Figure 3 - Aerial photograph from the north, 1939.

The pattern of the landscape up to the start of the Second World War is shown on figure 3. By then, Sir Philip Sasson had planted weeping willows around the lake. One has been retained on the south bank and there are several on the north bank.

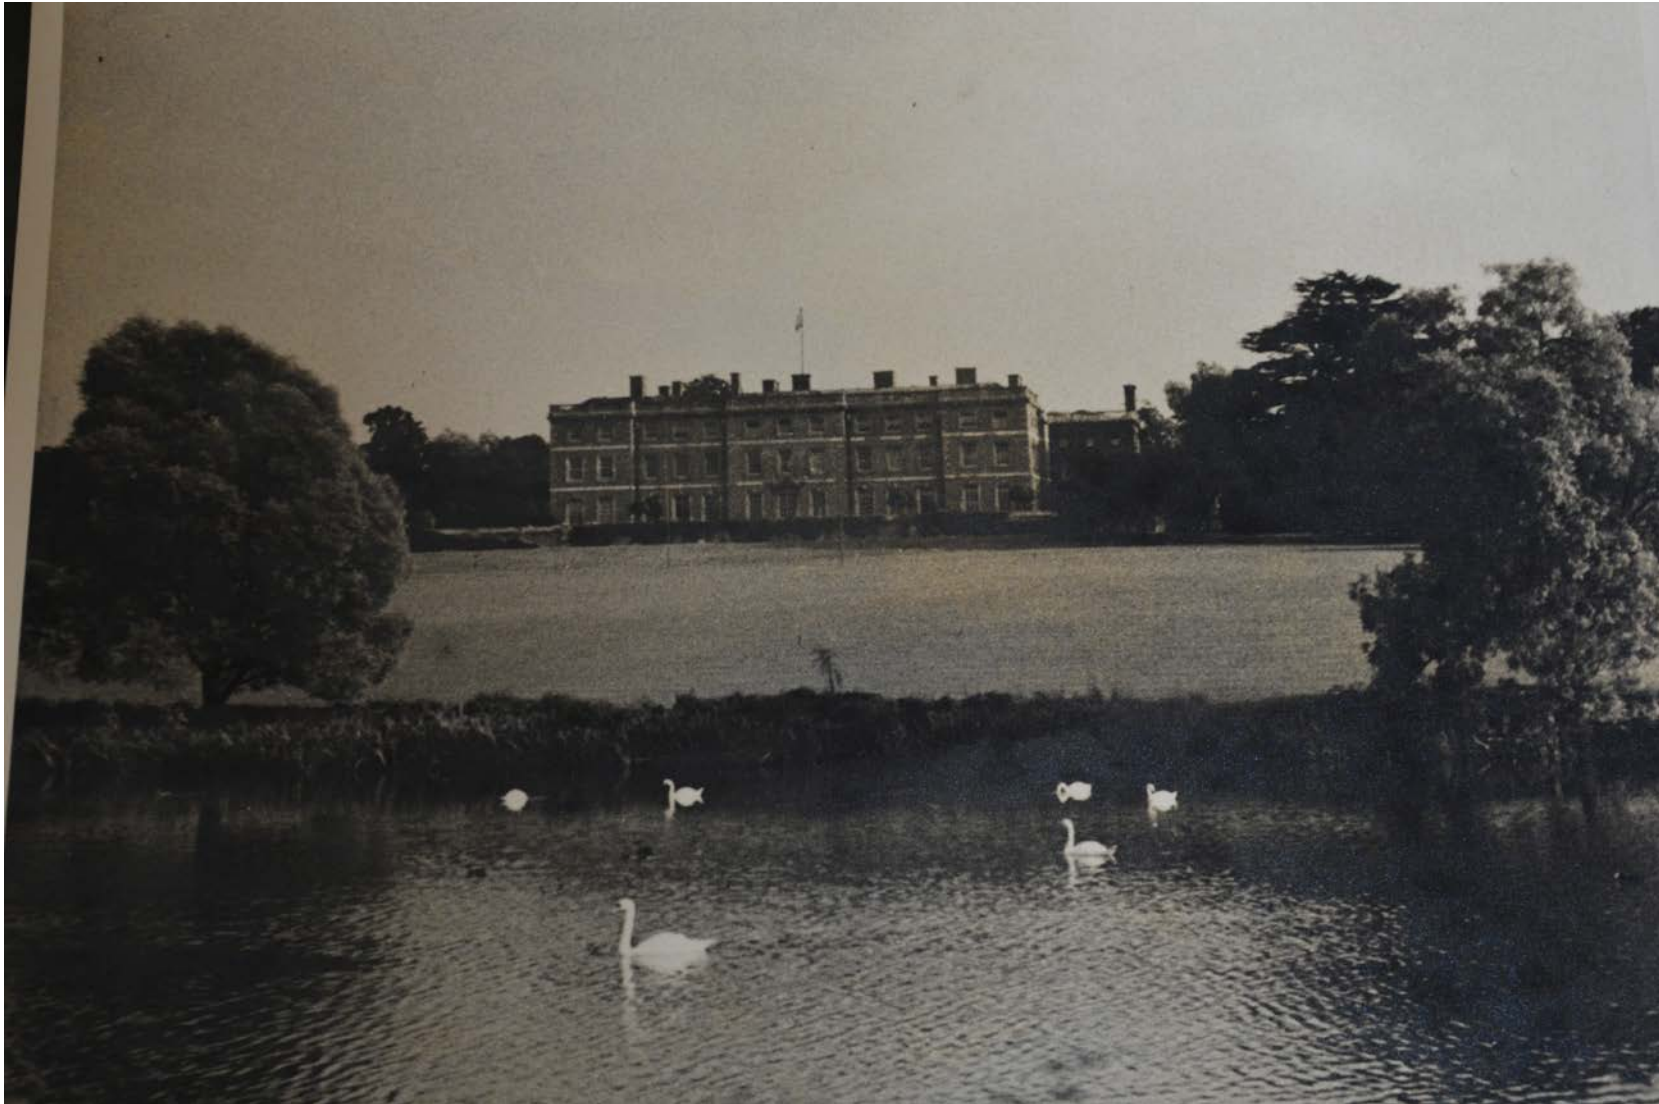
Figure 4 - The view across the lake from the north in the 1930's.

The views from the north bank across the lake (Figure 4) showed the dominant position of the mansion.

This setting of the mansion is one of the most important aspects of the site both as a core feature of the registered park and the setting of the grade II listed mansion.

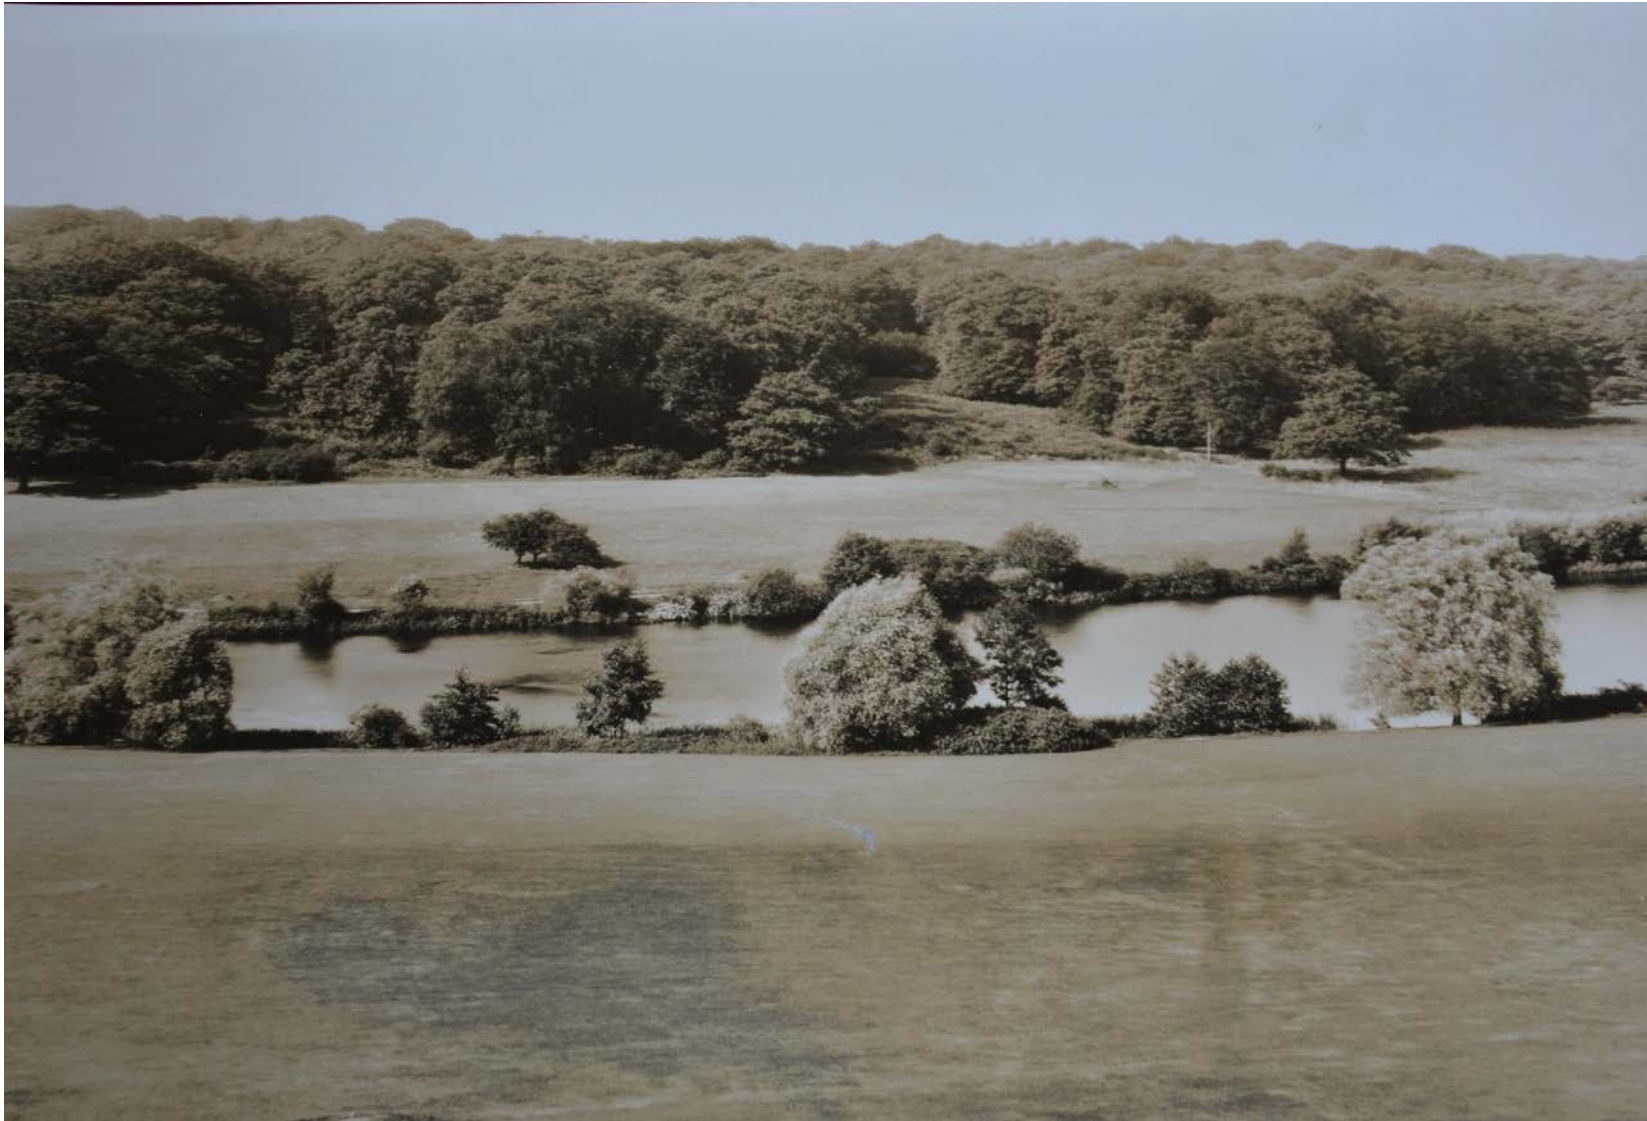
Figure 5 -The view across the lake from the mansion terrace in the 1930's.

The views from the mansion terrace were across the lake to a landscape of interlocking woodland, individual trees and grassland.

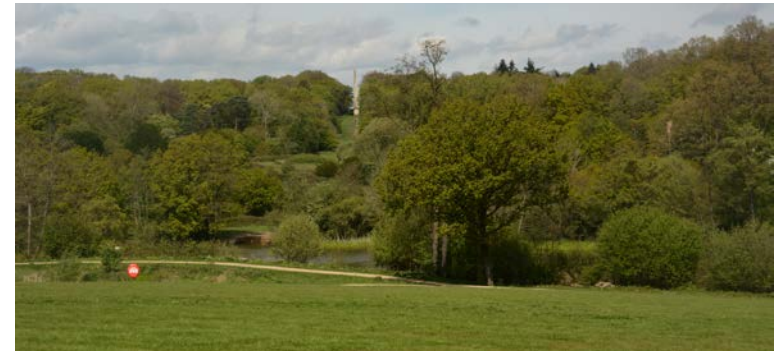
Figure 6A - View from the mansion terrace

The full sweep of the view from the mansion terrace (figure 6A) has Camlet Wood on the horizon B with a wide arc to the east and west. The view fades into woodland to the west and Ice House Wood/Williams Wood to the east. There are no particular management issues here except that historically Ice House Wood may have been thin enough to permit views through to the farmland. If one is now required, some management of the wood may be necessary.

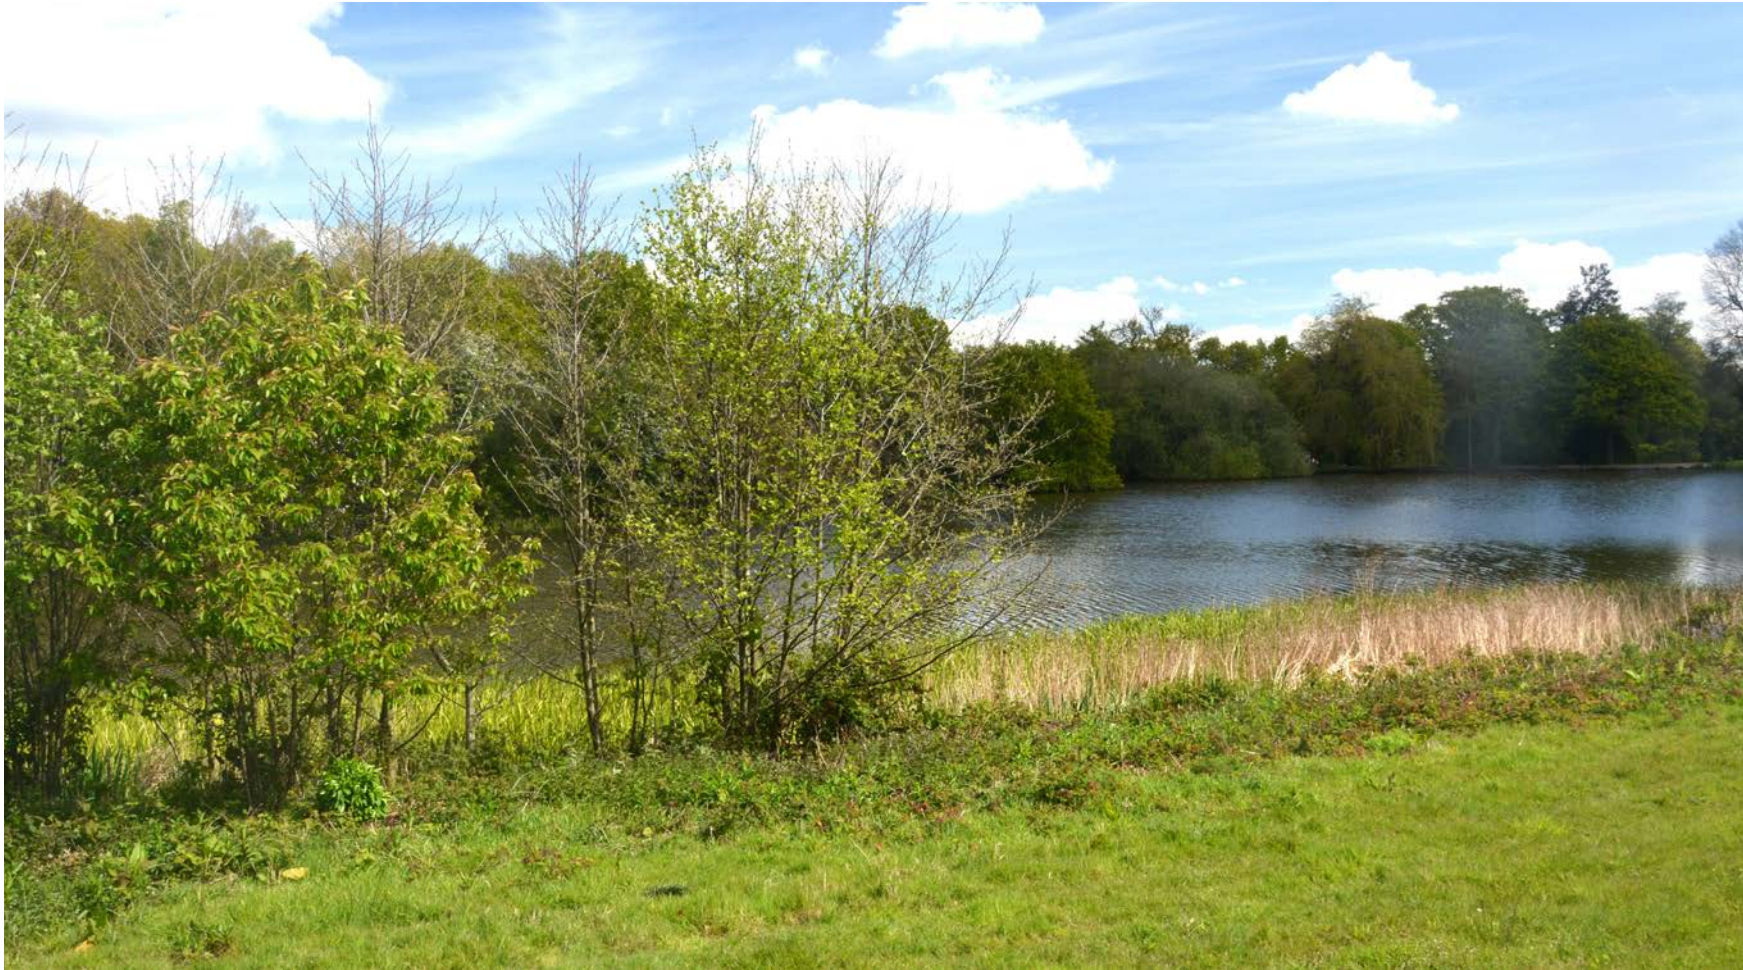
Figure 7 - Looking across the lake from the south bank.

Since the 1960s, trees and shrubs gradually encroached around all sides of the lake.

The south bank has now been cleared and has a fringe of marginal aquatics, together with willow and alder cut on a short rotation.

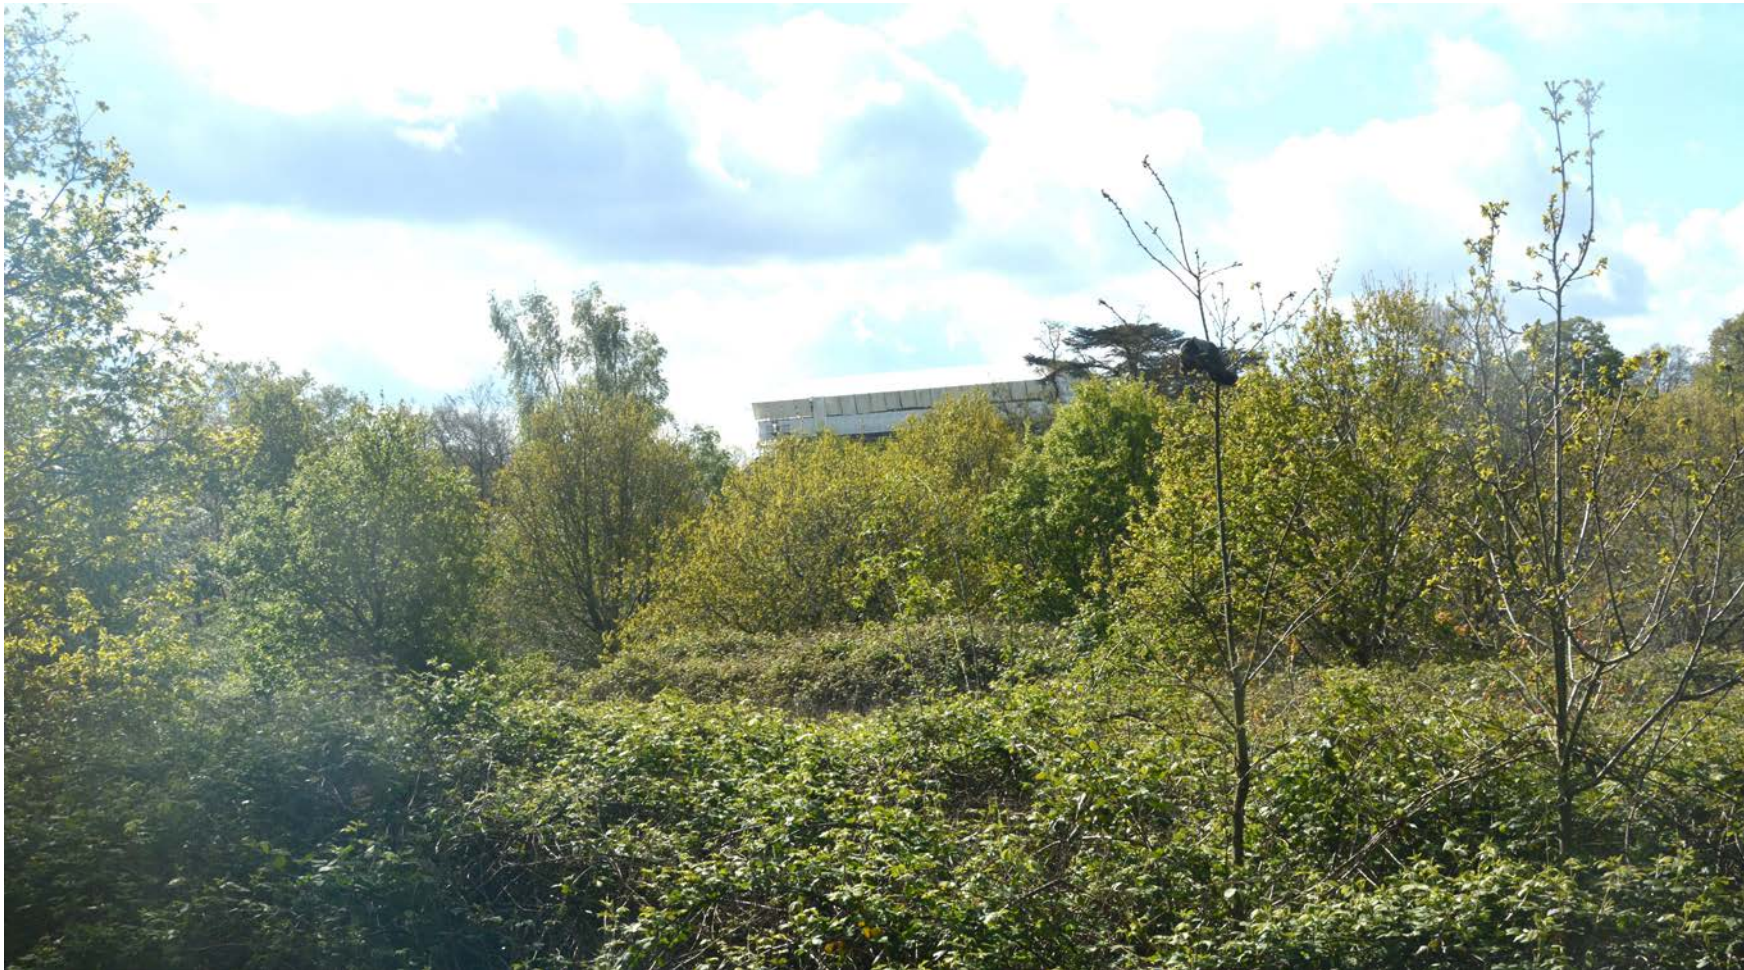
Figure 8 - The view from the north edge of the north bank.

The mansion can only be seen from a few clearings and the vegetation is largely impenetrable. Even a very restricted view like this will soon be lost.

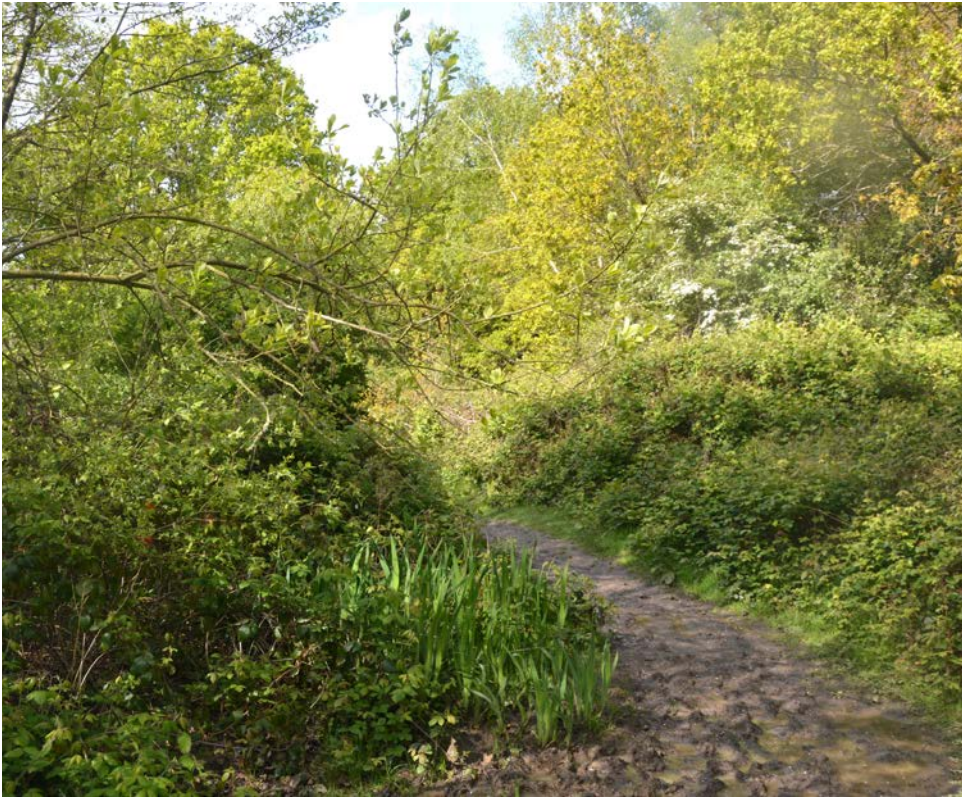
Figure 9.1 - For most of the lake edge - about 80m - there is dense scrub with patches of wetland vegetation like the iris seen here.

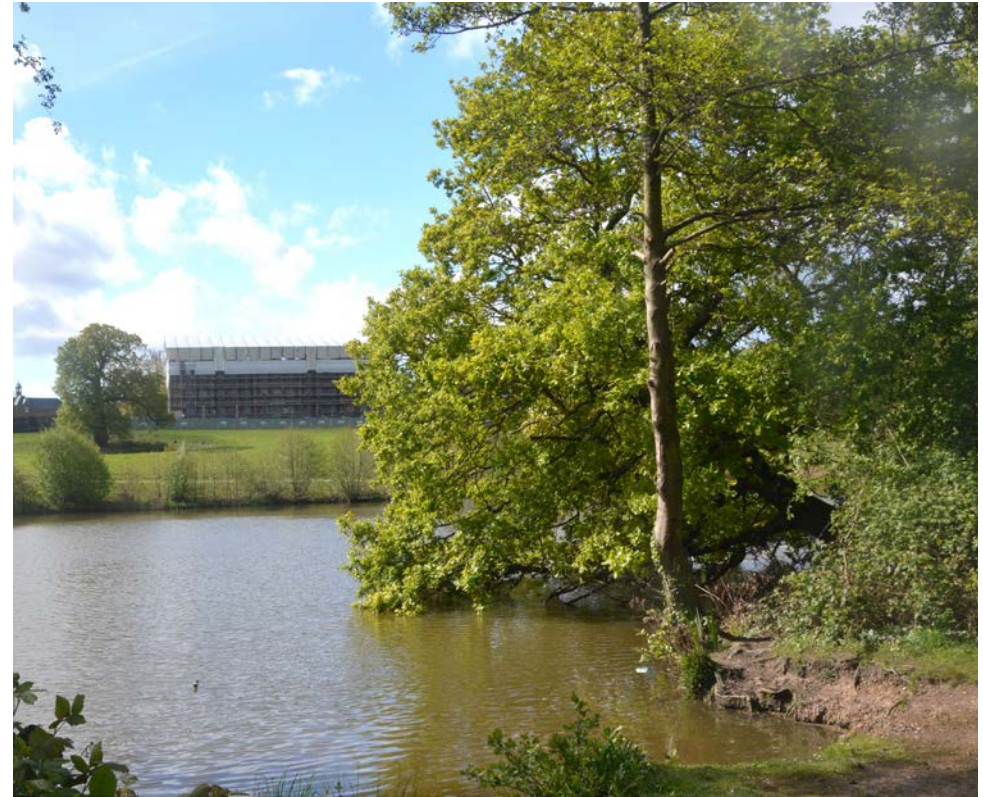
Figure 9.2 - In the few gaps in the edge vegetation the view of the mansion that will be created by scrub clearance can be seen.

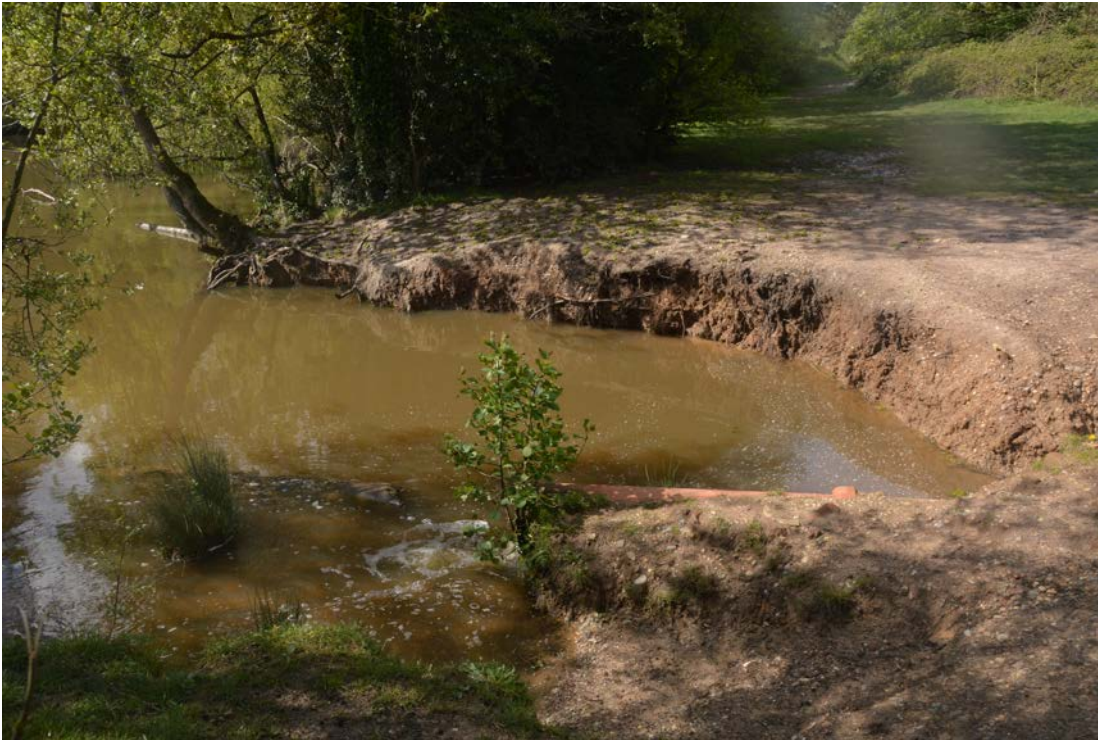
Figure 10.1 - This is the worst case of erosion of the edge, where erosion around an outfall has been accelerated by wave action.

The edge here takes the full force of the north-easterly winds and there are many eroded sections. It is impossible to judge them fully from the bank but they cover approximately 50% of the edge.

A specialist company to repair the eroded areas and provide a soft edge to combat erosion based on native species.
