Trent Park North Lake Restoration Proposals

A guide to how Enfield Council will help restore and manage the landscape of the north lake

Restoration of the Historic Landscape at Trent Park Mansion and Lake

Trent Park, Enfield
Document Reference: 1441/023 Rev C
May 2024

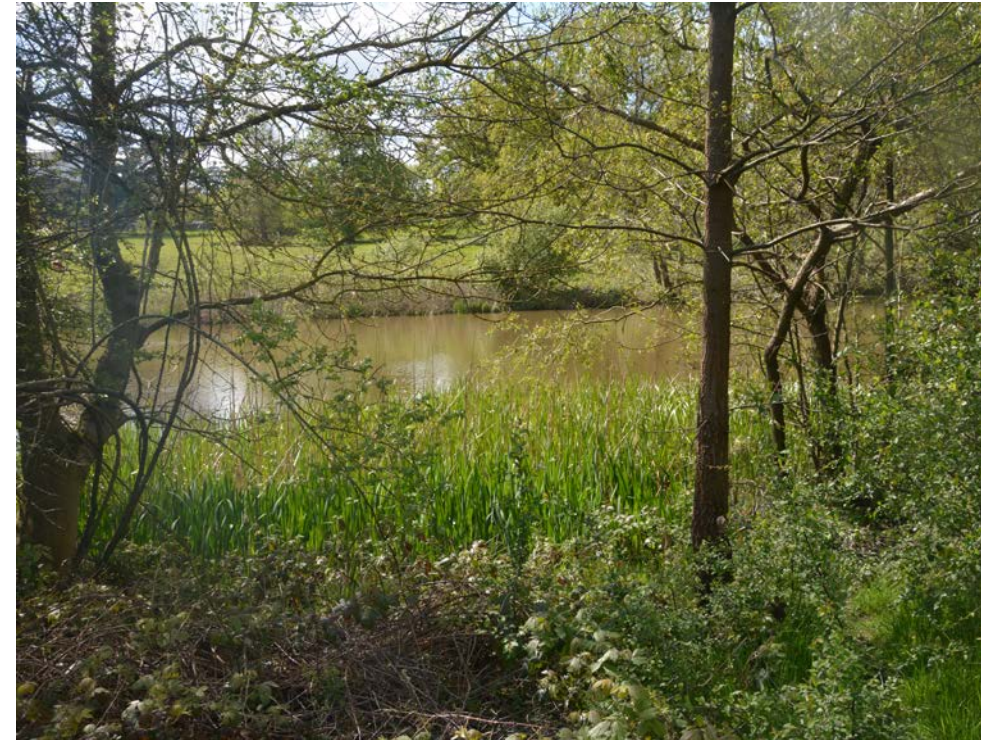
Figure 10.2 - There are some sections with an established soft edge of marginal aquatics - in this case mainly Branched Bur-reed, similar to those on the south bank.

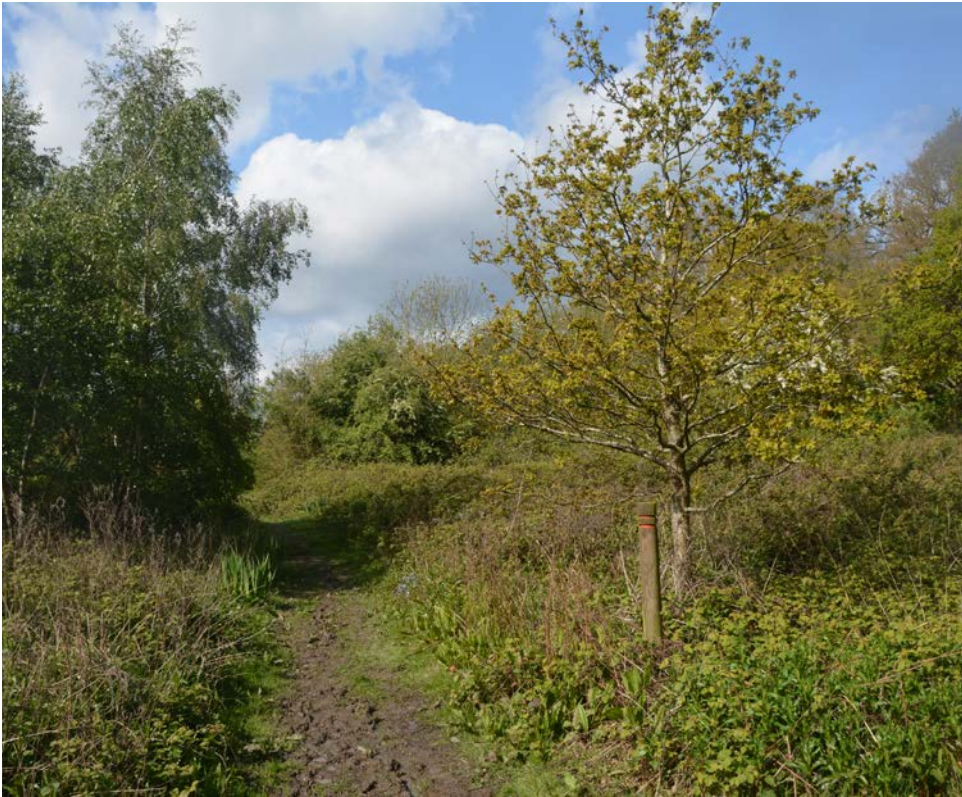
Figure 13.1 - There is a good range of trees that could be retained particularly in the size class of the oak shown here but there needs to be a good distribution across the whole of the site and between ages so that the tree cover is self-sustaining.

Clear other scrub in two phases and mow the grassland with a forage harvester removing all arisings. Clear the trees leaving 20 below 150mm diameter, 20 at 150-300 mm and 20 at over 300mm diameter. These should include hawthorn, birch, alder and willow and should have as even a distribution across the site as possible. The trees marked on figure 12 are just indicative and choice should be based on site judgement. It should allow for retaining small clusters where thinning to one tree need to be phased.

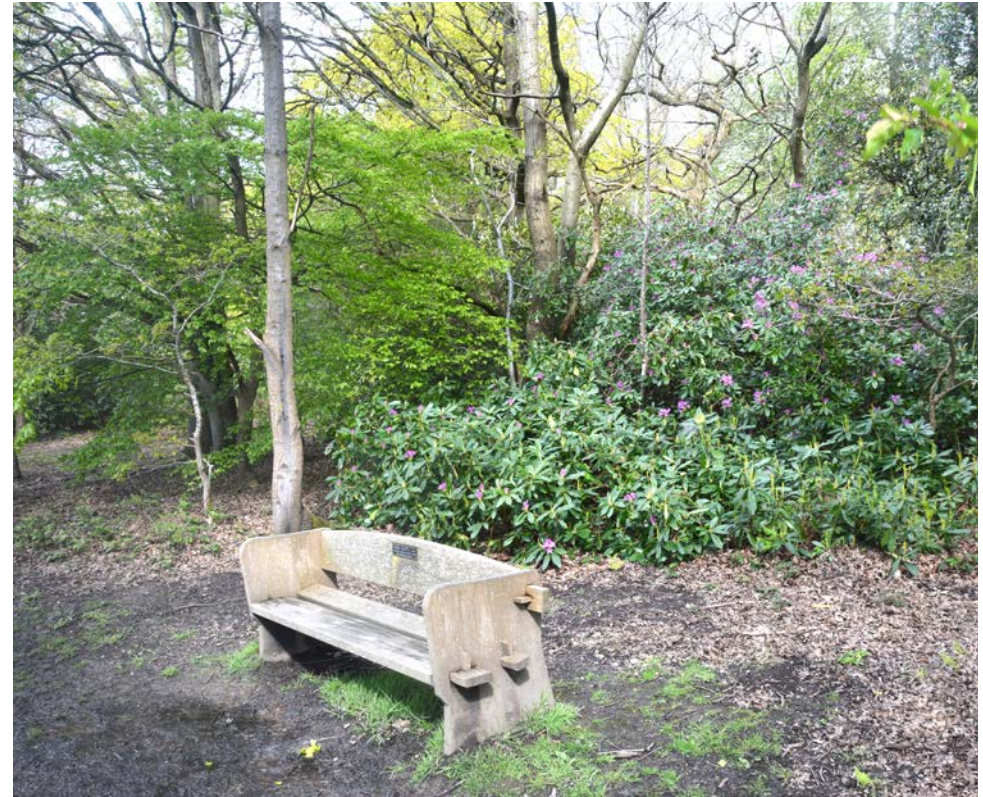
Figure 13.2 - Coppicing of the native shrubs and removal of rhododendron in a 10m band along the edge of Camlet Wood will compensate for the short-term changes to the north bank scrub.

In order to provide compensatory south-facing scrub the southern edges of Camlet Wood could be coppiced.

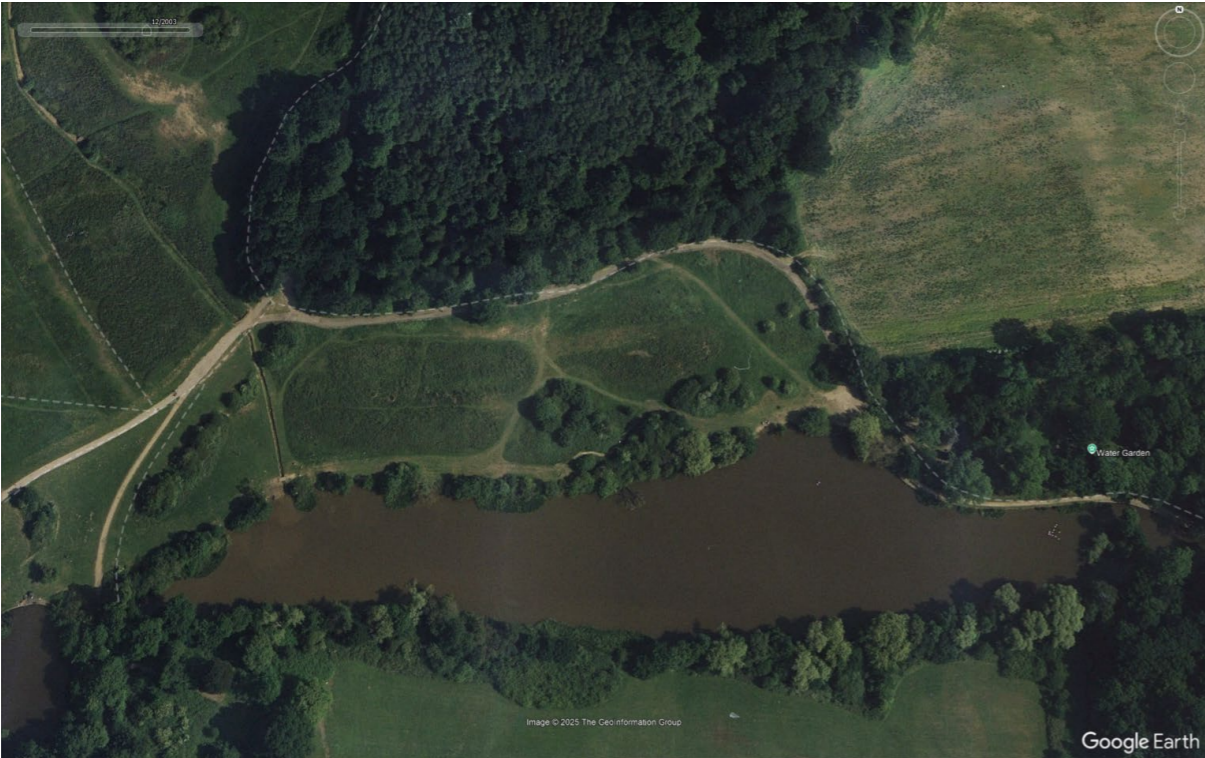
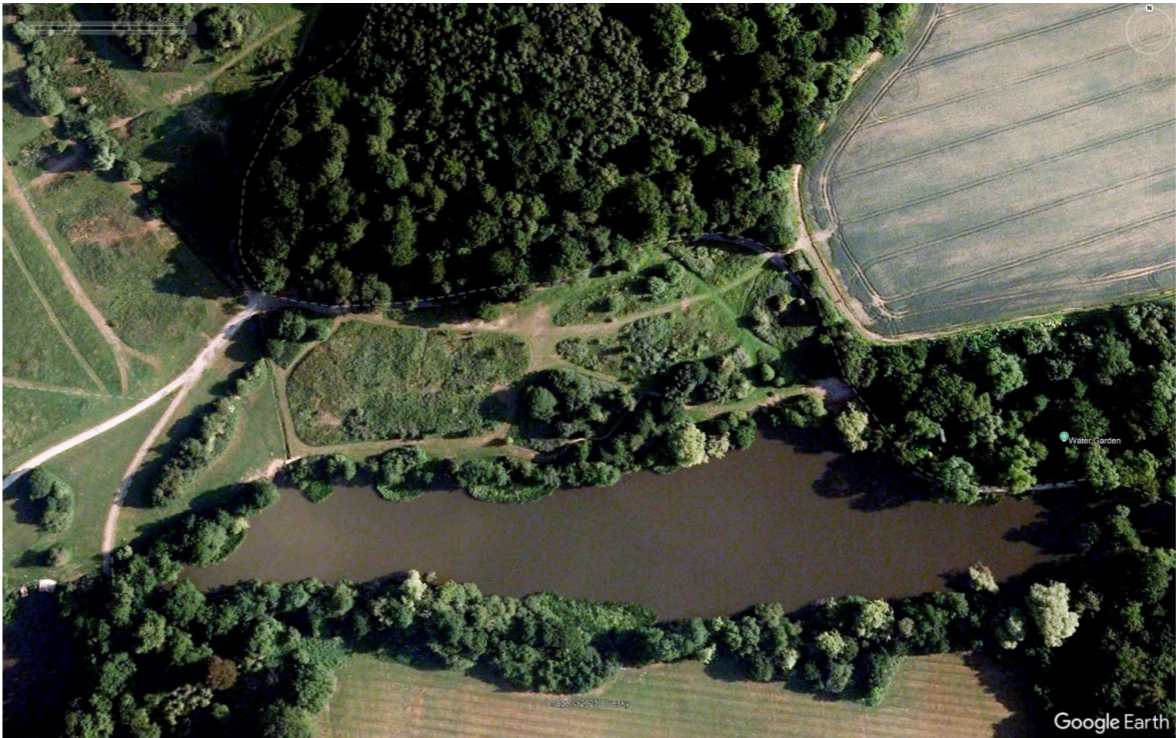
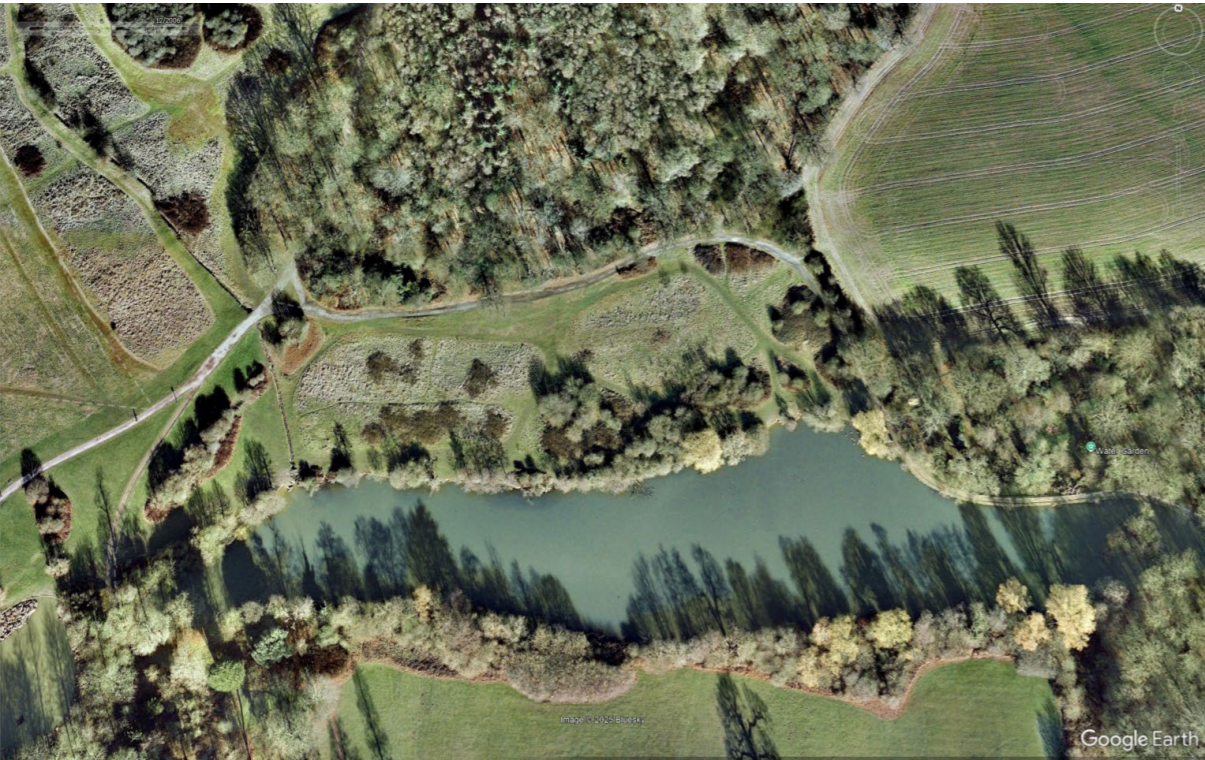
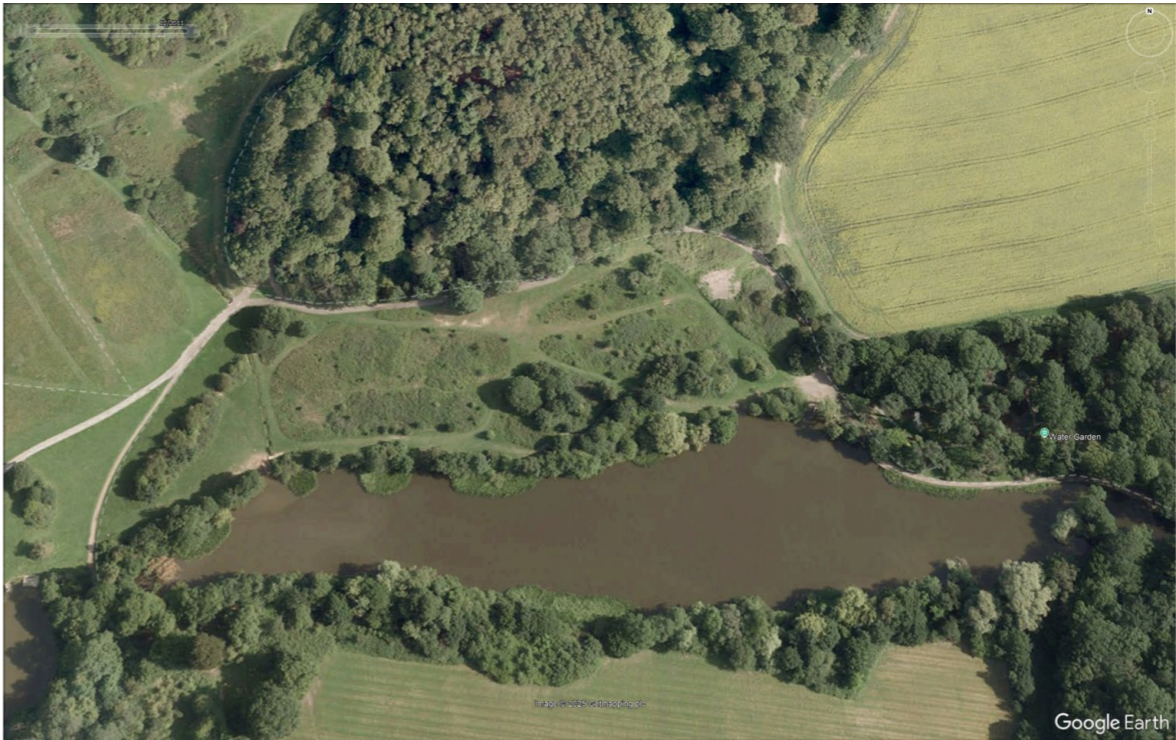
Appendix B - Trent Park North Lake
Aerial images from recent decades showing the vegetation of the north side of the lake
